SAS Superstructure

Daily Diary Report by Bid Item

Diary #: 234 Const Calendar Day: 518 Date: 08-Feb-2011 Tuesday

04-0120F4
04-SF-80-13.2/13.9
Self-Anchored
Suspension Bridge

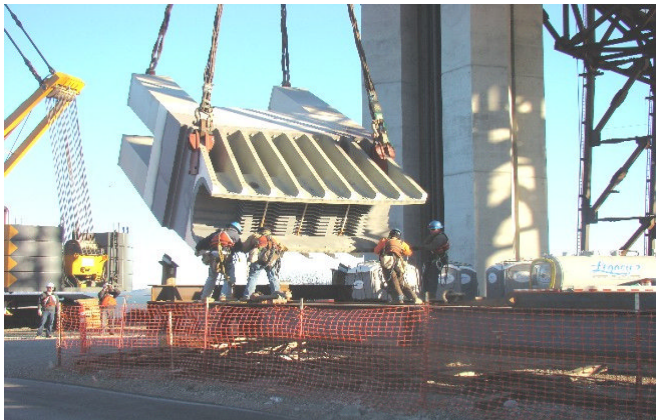
ABF ironworkers placing the jacking saddle/frame onto the lifting cradle.

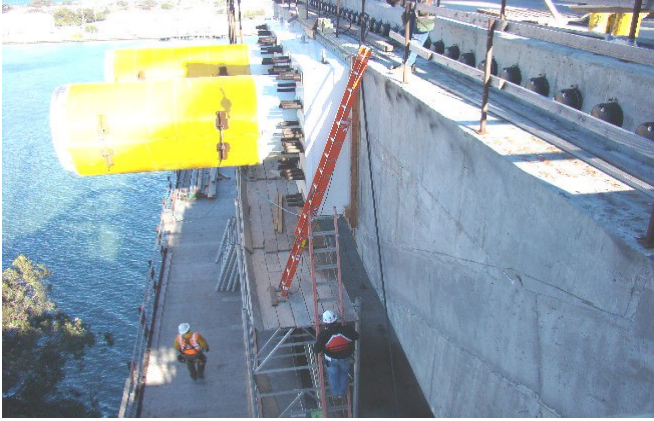
Conco carpenters water testing the W2W Hinge K grout pad formwork, a few leaks were found and then sealed with silicone caulking.

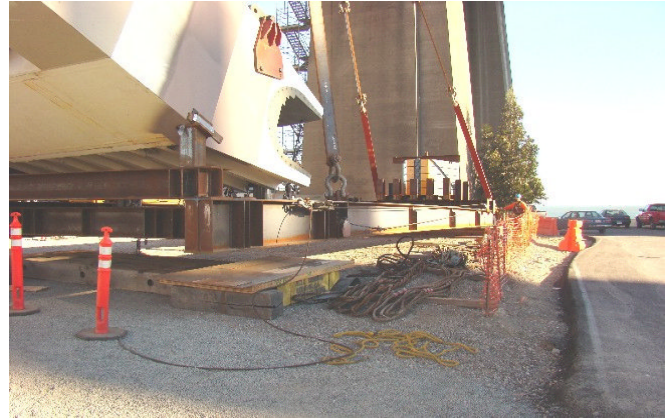
Test pick of the jackign saddle/frame, cradle, and counterweight. Excess deflection was observed in the cradle beams.
